**FORCED-ENTRY RESISTANCE TESTS
AS PER THE ASTM F476-84(2002) TESTING
PROCEDURE ON AN ENTRANCE DOOR
- COMPARATIVE STUDY -**

TEST REPORT SUMMARY OF RESULTS	
Product type:	Swinging Entrance Door (Insulated Steel Door)
Product series/model:	Inswing Single Entry Door
Slab dimensions:	808 mm width x 2006 mm height (32 in. width x 79 in. height)
Test Results:	Grade 10 (Door evaluated without any security system) Grade 30 (Door evaluated with a competitor's security system) Grade 40 (Door evaluated with the <i>Safe Door Systems</i>)
Test completion date:	10/01/2010

**Report: AI-03043-A2
Report date: October 8th, 2010**

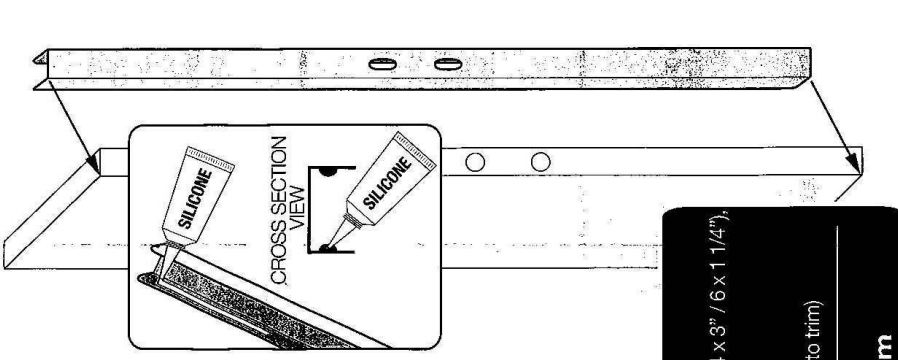
<p>CROSS SECTION VIEW</p>
<p>3 12" Striker Installation</p> <p>A) Template Tracing B) Chisel Frame C) Install 12" Striker</p>	<p>A. Mount 12" striker onto frame with 2 x 1 1/4" screws temporarily (as shown). Trace outline with pencil</p> <p>B. Remove 12" striker and chisel frame to allow 12" striker to fit flush</p> <p>C. Install 12" striker onto frame using screws provided</p> <p>*NOTE: See Step 4</p>

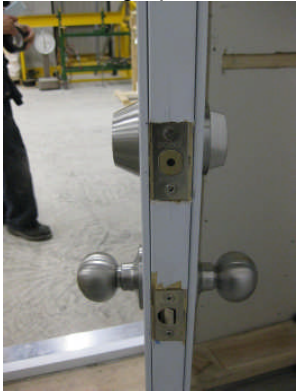
<p>Grade 10</p>	<p>Photograph no.4</p>

<p>The door latch is damaged and cracks are observed in the wooden edge of the slab at dead bolt faceplate location.</p>	<p>Photograph no.10</p>

- Note:
- 1) The door latch is damaged, but still operational. Cracks are observed in the wooden edge of the slab at dead bolt faceplate location.
 - 2) The door slab is broken and damage is observed on the locking devices, strikers and frame.

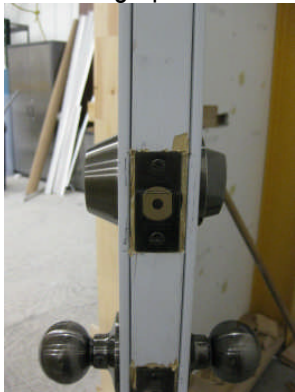
<p>Cracks are observed in the wooden edge of the slab at faceplates locations.</p>	<p>No damage is observed</p>
<p>Grade 20</p>	<p>Photograph no.5</p>

- 3) Cracks are observed in the wooden edge of the slab at faceplates locations.
 - 4) The door slab is broken. The locking devices are damaged, but still operational.

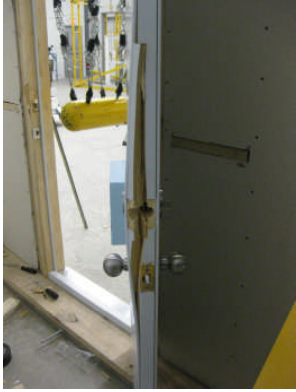
<p>The door slab is broken and damage is observed on the locking devices.</p>	<p>Photograph no.11</p>

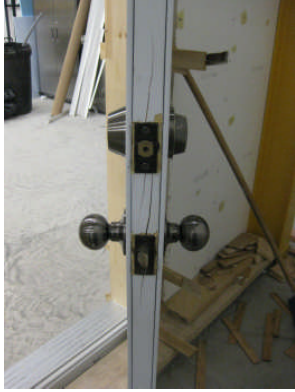
<p>The door slab is broken and the locking devices are damaged, but still operational.</p>	<p>No damage is observed</p>
	<p>Photograph no.6</p>

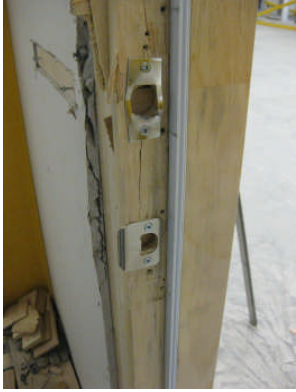
<p>Damage is observed on the frame and strikers</p>	<p>Photograph no.12</p>

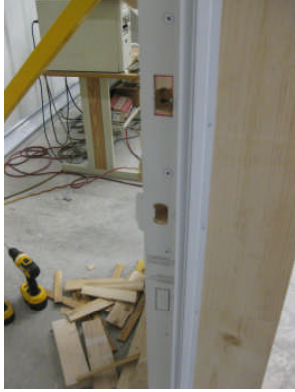
<p>No damage is observed on the striker plate.</p>	<p>No damage is observed</p>

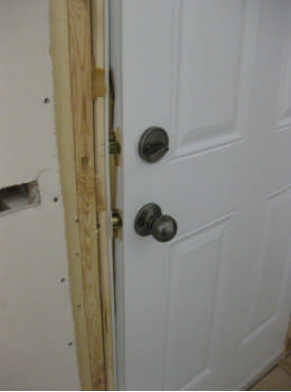
<p>The door slab is broken and the locking devices are no longer operational.</p>	<p>Photograph no.19</p>

- 5) The door slab is broken and the locking devices are no longer operational.
 - 6) The door slab is broken and opens under the impact allowing entrance.

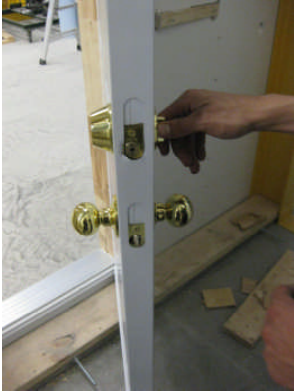
<p>Cracks are observed in the wooden edge of the slab at faceplates locations.</p>
<p>Grade 40</p>	<p>Not performed</p>	<p>Photograph no.14</p>

- 7) Cracks are observed in the wooden edge of the slab at faceplates locations.
 - 8) Deformation is observed on the striker plate with damage to the frame. The dead bolt is damaged, but still operational.

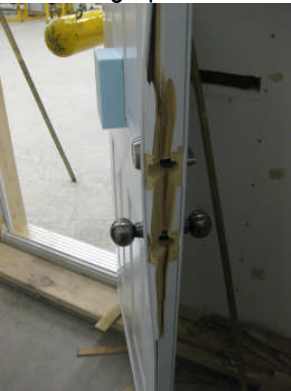
<p>The door slab is broken and opens under the impact allowing entrance.</p>	<p>Photograph no.20</p>

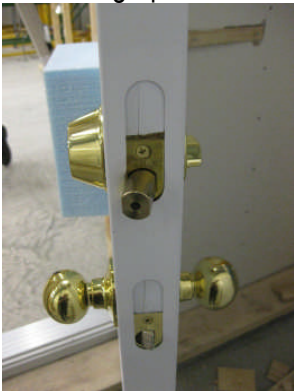
<p>Cracks observed in the slab and the dead bolt is damaged, but still operational.</p>
<p>Grade 40</p>	<p>Not performed</p>	<p>Photograph no.15</p>

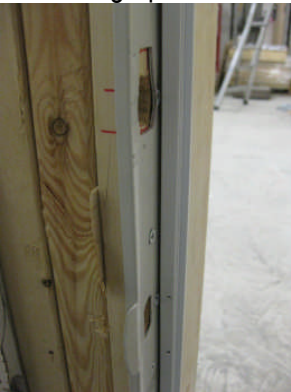
<p>Deformation is observed on the striker plate.</p>	<p>Photograph no.21</p>

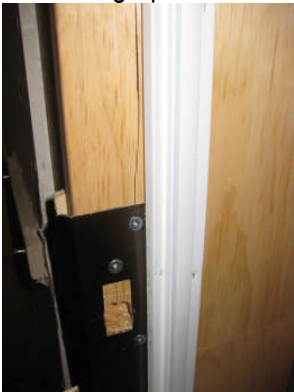
<p>Deformation observed on the striker plate with damages to the frame.</p>
